**COMMONWEALTH OF KENTUCKY
NATURAL RESOURCES & ENVIRONMENTAL PROTECTION CABINET
DEPARTMENT FOR ENVIRONMENTAL PROTECTION
DIVISION OF WATER**

**APPLICATION FOR PERMIT TO CONSTRUCT ACROSS OR ALONG A STREAM
AND / OR WATER QUALITY CERTIFICATION**

1. **OWNER:** Boone County Fiscal Court
Give name of person(s), company, governmental unit, or other owner of proposed project.
MAILING ADDRESS: 2950 Washington Street, Burlington, KY 41005

Task 1 – North Branch Stream Restoration

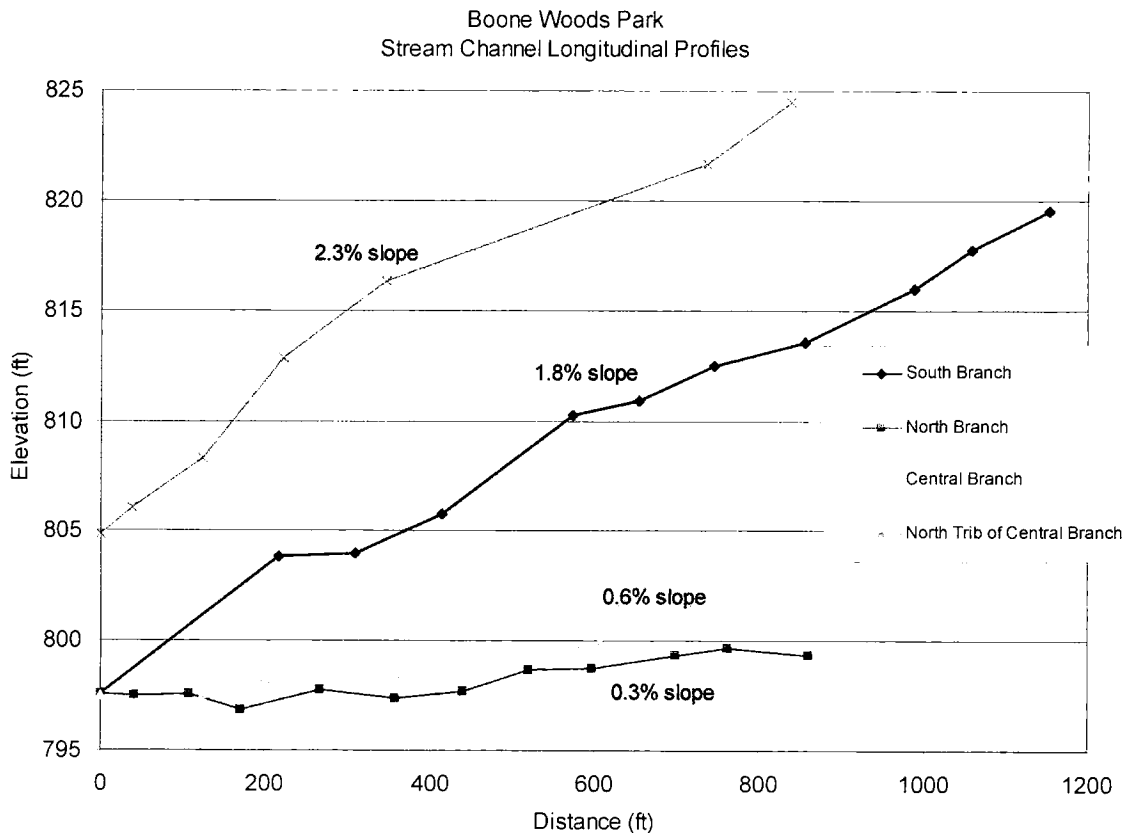
In the following sections, descriptions of current conditions and restoration plans are provided. In addition, the locations of the four subject streams are illustrated on Figure 5, current stream conditions are scored in Appendix B, and longitudinal profiles are provided below.

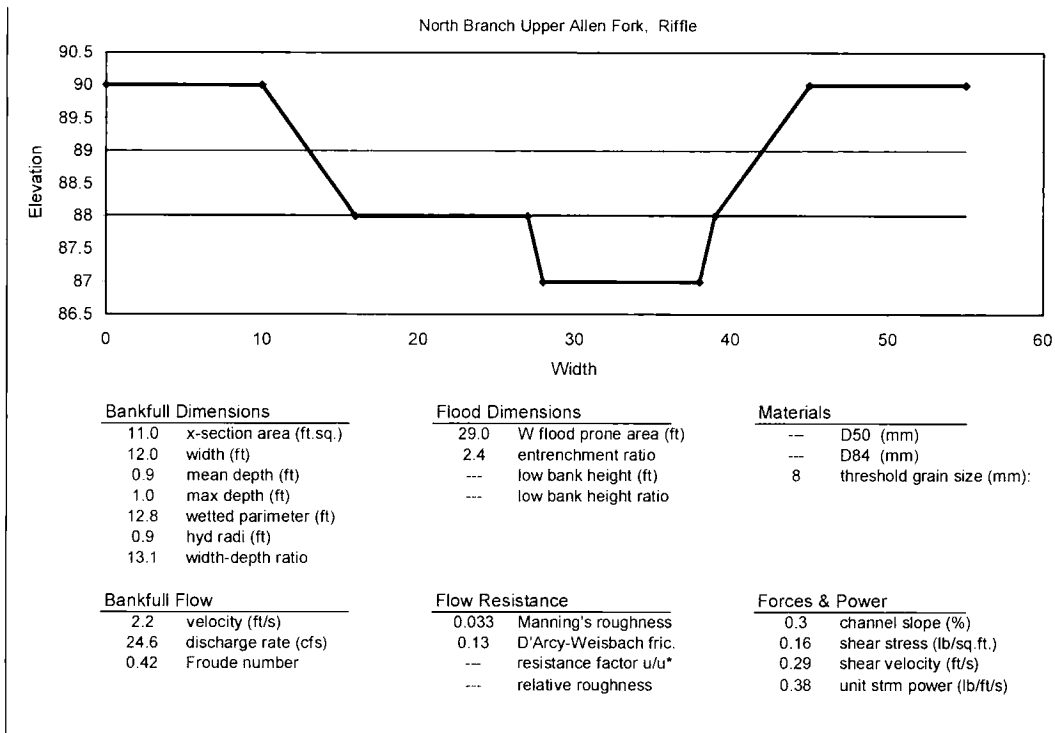
Cross section and hydraulic calculations utilize Ohio DNR Reference Reach Survey 4-3 L.xls

In order to increase the sinuosity of the stream, the stream length will be increased from 770 to 840 feet, relocating sections of the channel into the former floodplain to the extent practical, to achieve an increased sinuosity of 1.14 (Figure 6). The bankfull width of the restored channel will be 12 feet, with the floodplain elevation one foot above the streambed. The floodplain width will be 11 feet, with sideslopes above the floodplain sloped at 3:1, creating an entrenchment ratio of 2.4 (see cross section below).

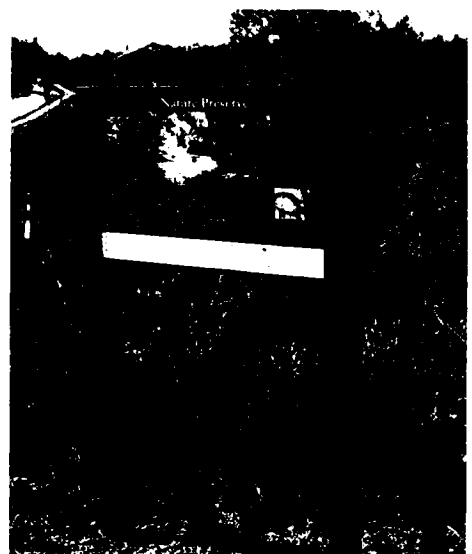
Interpretive sign (2' x 3').

- An interpretive natural area sign will be installed at a conspicuous location.
- Access control fencing (e.g., spit rail fence) will be installed along reaches of the stream particularly vulnerable to damage from frequent visitor access.
